Isolated Anterior Lens Capsule Rupture Secondary to Blunt Trauma: Pathophysiology and Treatment

Keywords: Blunt eye trauma, lens anterior capsule rupture, traumatic cataract

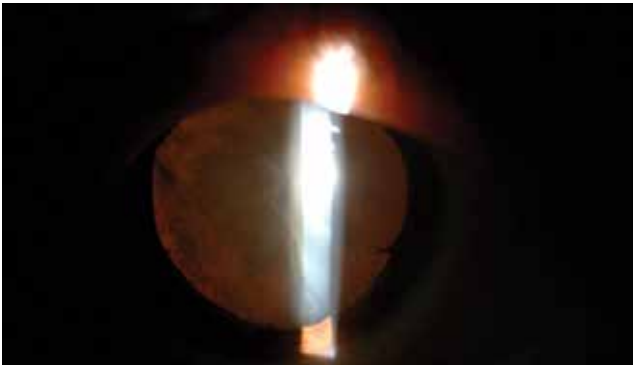
Figure 1. Biomicroscopic anterior segment photograph of the isolated anterior lens capsule extending from 7 to 11 o'clock

A 25-year-old male presented with periocular pain the day after sustaining a blunt trauma to the right eye with a piece of wood. At presentation, his best corrected visual acuity (BCVA) was 1/10 in the right eye and 10/10 in the left eye. Intraocular pressure (IOP) was 10 mmHg in the right and 12 mmHg in the left eye. Slit-lamp examination of the right eye revealed mild eyelid edema, 1+ conjunctival injection, clear cornea, an anterior lens capsule rupture bisecting the lens capsule along the 7 to 11 o'clock line extending under the superior and inferior iris margins to the lens equator, and traumatic cataract that did not yet seriously impede visualization of the fundus (Figure 1). Retinal examination done at this stage revealed no pathology in the posterior pole, midperipheral or peripheral retina.

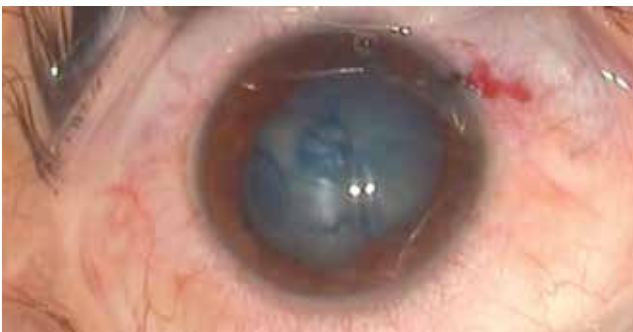
Figure 2. Intraoperative image of the severe traumatic cataract and the anterior lens capsule rupture visualized with trypan blue

Visual acuity was 1/10 on the third day after the trauma; however, due to increasing lens opacity, it decreased to hand motions by day 7 (Figure 2). B-scan ultrasonography and orbital computed tomography (CT) were performed to rule out foreign body and globe rupture and to document the patient's current status. No intravitreal foreign body or retinal pathology was detected on B-scan ultrasonography (Figure 3). Orbital CT revealed narrowed anterior chamber and increased lens volume and reflectivity compared to the healthy eye. Furthermore, the globe was observed to be intact and no fractures were detected in the bones of the orbit (Figure 4).

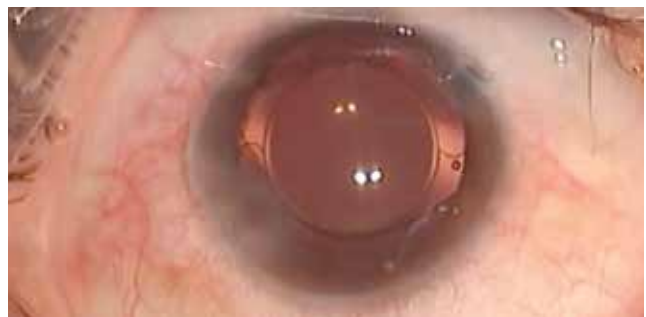
Figure 5. Postoperative anterior segment image

irrigation/aspiration technique. A foldable, acrylic posterior capsule intraocular lens was implanted by injection into the sac and anterior capsulorhexis was performed in half-circles on the temporal and nasal sides in the pupillary plane. The zonules and posterior capsule were observed as intact after the procedure. The corneal incisions were closed using hydration, without sutures (Figure 5). Uncorrected visual acuity was 20/20 on the first postoperative day.
